ARMY RESEARCH LABORATORY

Metallurgical Examination of Failed Spiral Bevel Gear P196, Part No. 145D6302

ARL-TR-1432

AUGUST 1997

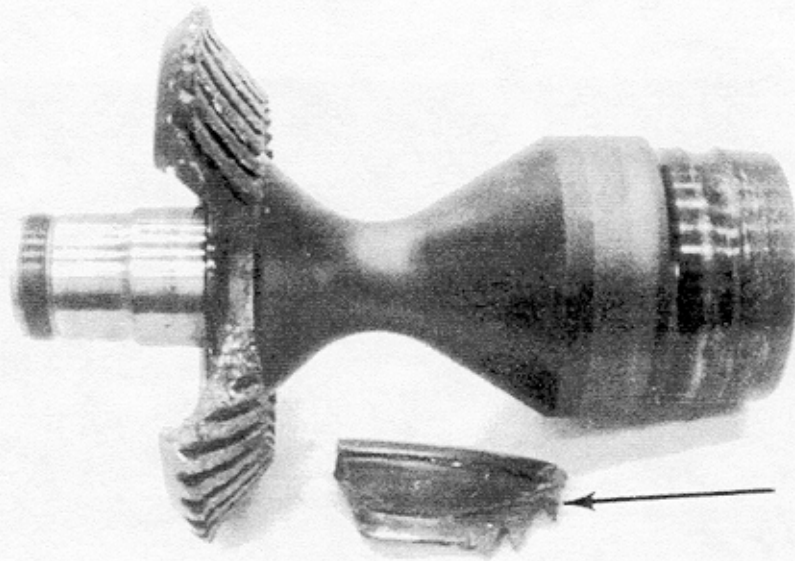
A spiral bevel transmission gear (see Figure 1, taken from the Boeing report) from a CH-47D Army cargo helicopter failed during a training flight at Fort Meade, Maryland, leading to an immediate landing. Inspection of the Number 2 engine transmission revealed that an eight-tooth segment (of a 35-tooth gear) had fractured and penetrated the transmission housing. The failed component (Part No. 145D6302) was fabricated from Vasco X-2M steel and carburized to a required case hardness of 59 to 64 hardness Rockwell "C" (HRC). The failed component was originally examined by Boeing Helicopters (refer to Boeing Report [Materials Engineering Laboratory Report {MELR}] No. 93-105, dated 15 December 1995) [1], and subsequently shipped to the U.S. Army Research Laboratory (ARL), Weapons and Materials Research Directorate, for analysis. The broken part was subject to visual examination/light optical microscopy, chemical analysis, metallography, hardness testing/case depth measurement, X-ray diffraction, scanning electron microscopy (SEM) and energy-dispersive spectroscopy (EDS).

Figure 1. Optical Macrograph of the Failed Spiral Bevel Gear and the Fractured Eight-tooth Segment (denoted by the arrow). (The photo was reproduced from the Boeing report and reduced 70%.)

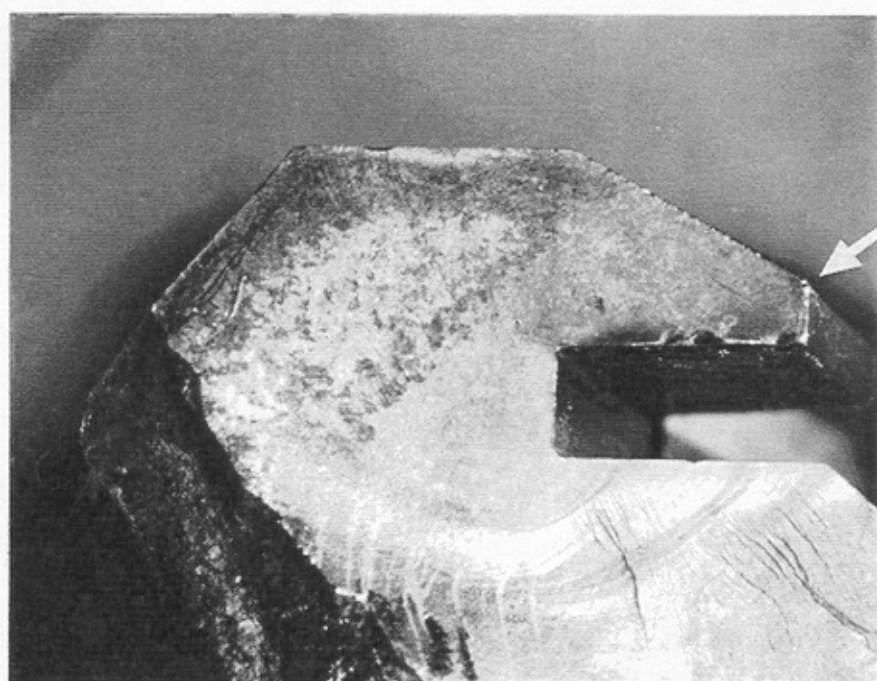
Visual examination and light optical microscopy of the fracture surfaces revealed characteristics consistent with a fatigue failure, including smoothness of fracture and beach marks (see Figure 2). The beach marks and radial lines on the fracture surface revealed that the origin was located in the damping ring groove portion of the gear at a darkened half-moon-shaped defect (see Figure 3). This region was located at the intersection of the 30° taper and the 7.125-inch diameter. The defect was oriented perpendicular to the direction of grinding, suggesting the possibility of a grinding crack. Further visual examination of the remaining component revealed small grinding cracks in the same area as the fracture origin.

Figure 2. Optical Micrograph of the Primary Fracture Surface Showing Evidence of Fatigue (beach marks). (Arrow denotes fracture origin; magnification 7.5x.)

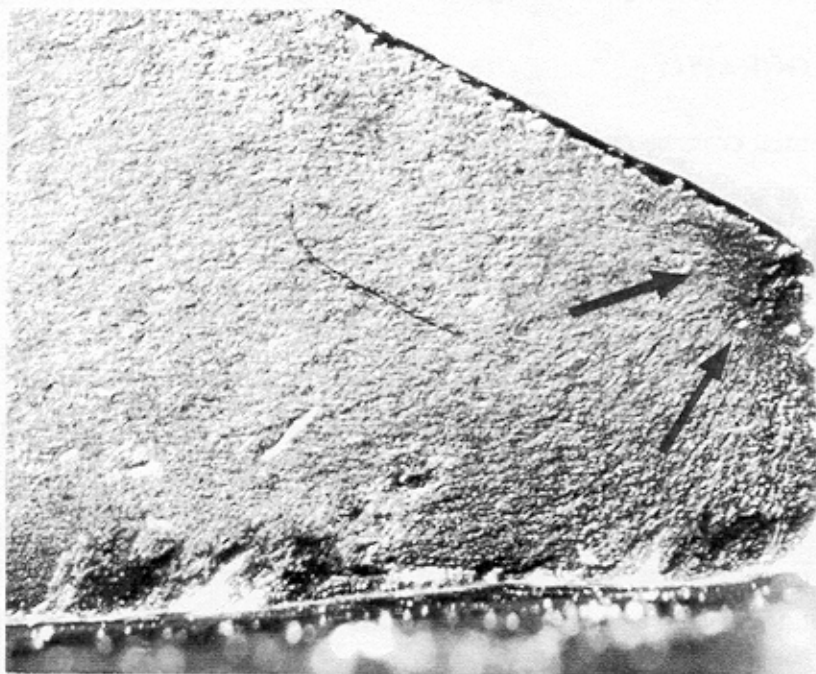
Figure 3. Magnified View of the Processing Defect Located at the Origin. (The grinding crack is denoted by arrows; magnification 40x.)

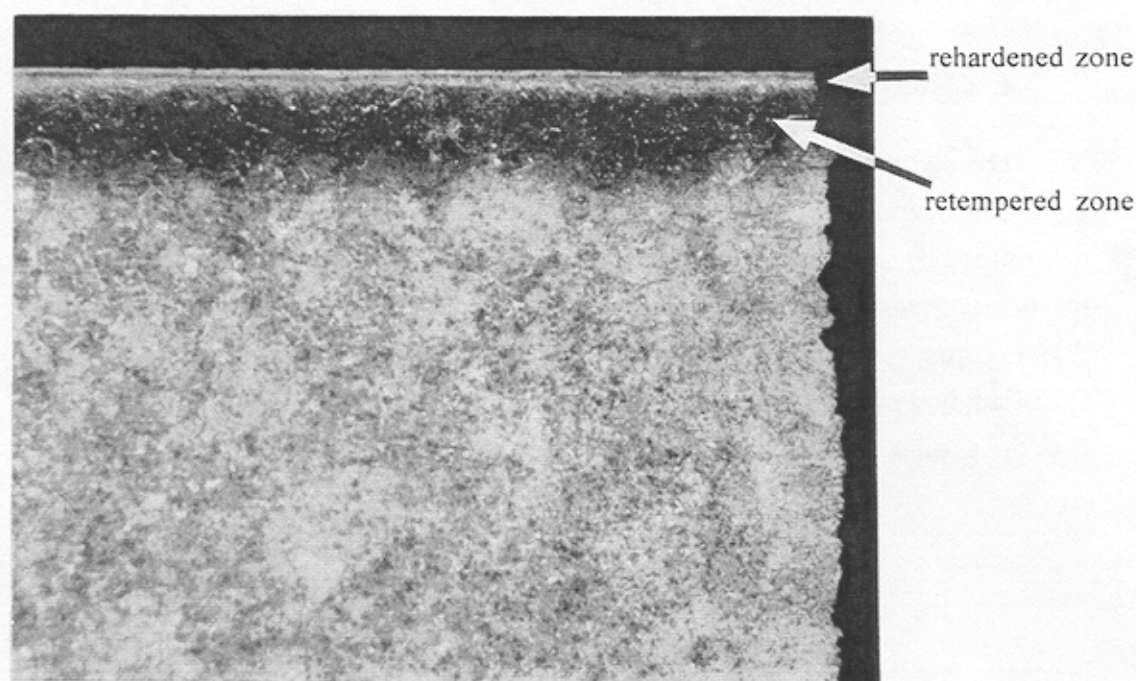
A circumferential cross section was taken through the origin to confirm that the pre-existing defect was a grinding crack. The sample was metallographically prepared and etched with Vilella's reagent (5 ml hydrochloric acid, 1 gram picric acid, and 100 ml ethanol). The sample showed evidence of rehardening (white region) and retempering (dark region) as shown in Figure 4. This pre-existing crack was oriented perpendicular to the direction of grinding, consistent with a grinding crack. Figure 5 is a montage showing the as-polished appearance of the fracture origin and several grinding cracks running parallel to the fracture plane. Figure 6 shows the same area after application of Vilella's reagent. Note that each grinding crack is contained within the grinding burn. Other grinding burns and grinding cracks were also noted adjacent to the fracture origin (see Figure 7). This burn was 0.43 inch away from the fracture origin. In addition, metallography revealed what appeared to be continuous carbide networks (CCNs) in the region of the gear that contained the origin (see Figure 8).

Figure 4. Metallographic Section Through the Origin. (Note the rehardened white layer and the retempered darkened layer caused by the grinding burn; Vilella's reagent; magnification 200x.)

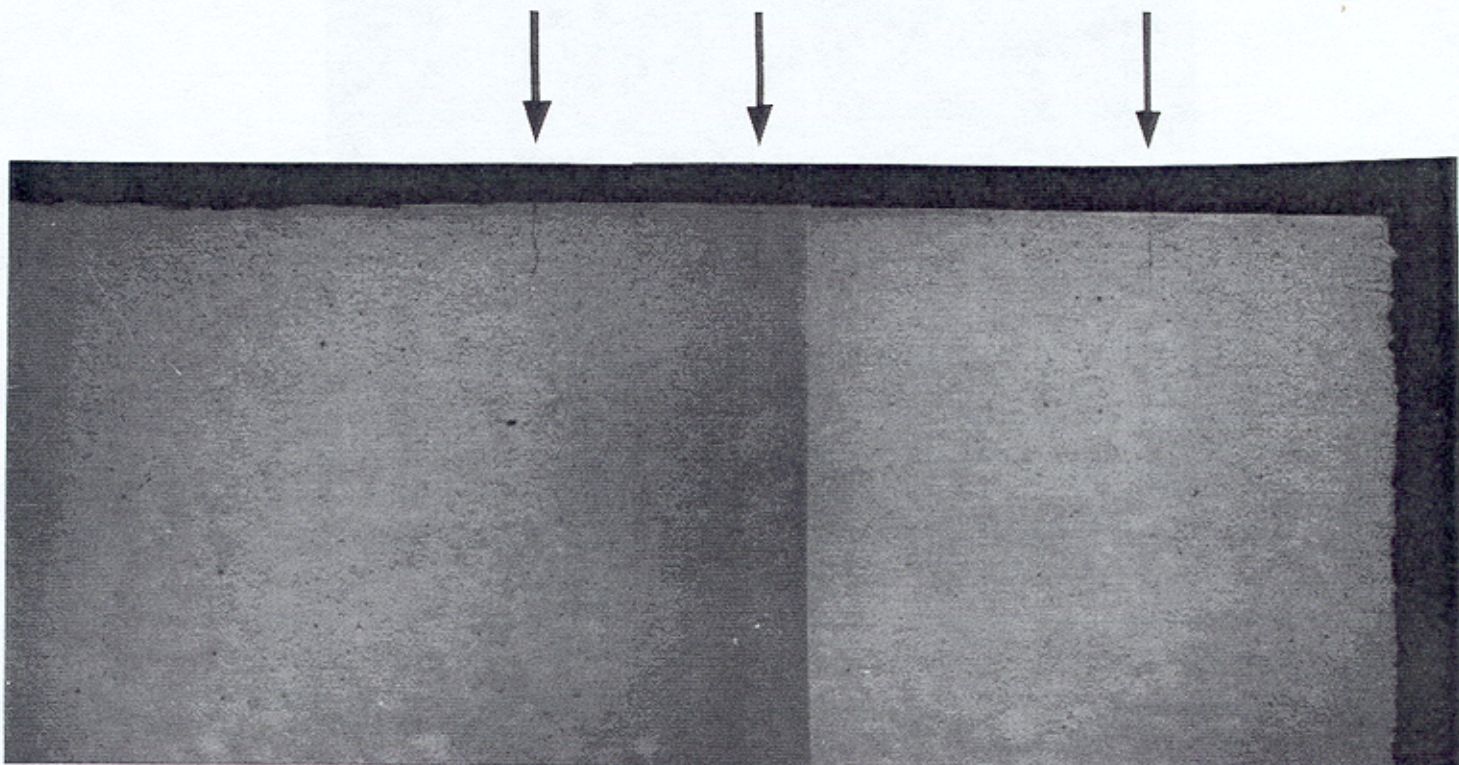
Figure 5. Montage of the Fracture Origin in the As-polished Condition. (Note the three additional grinding cracks [denoted by arrows] running parallel to the fracture plane; magnification 100x.)

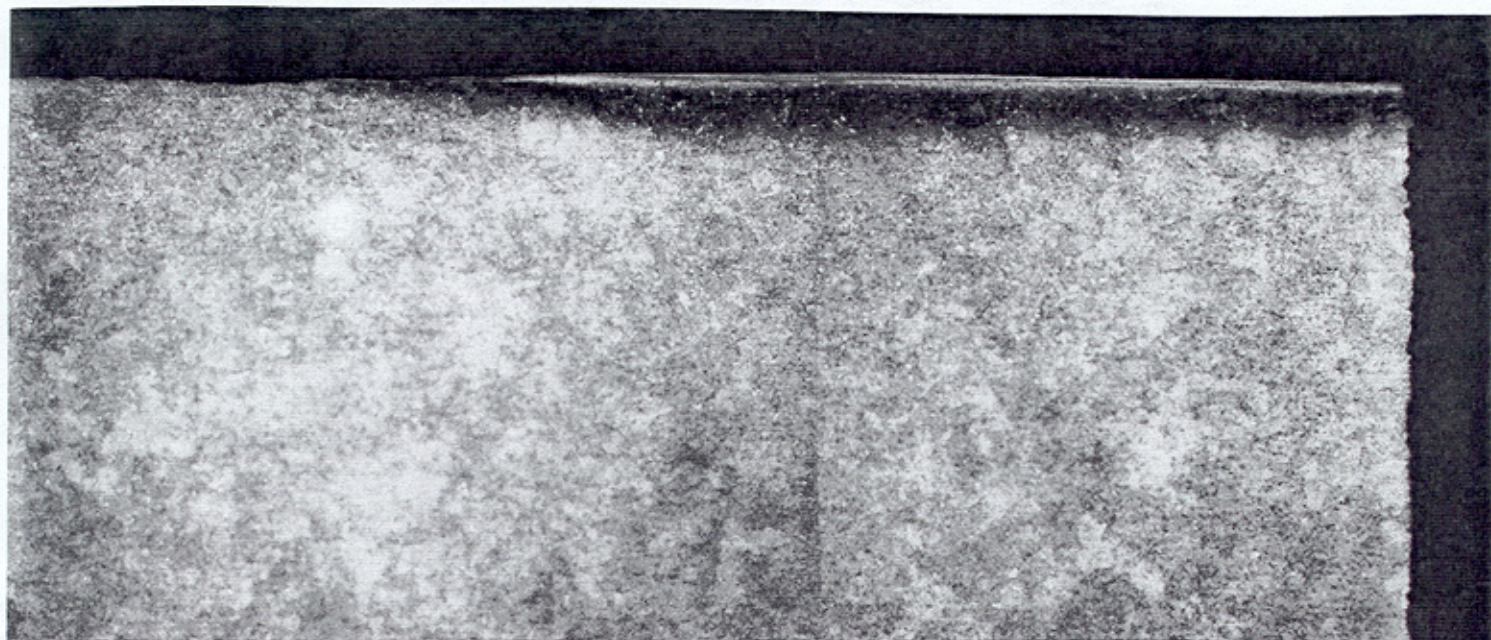
Figure 6. Montage of the Fracture Origin Shown in Figure 5, After Application of Vilella's Reagent. (Note that each crack is contained within the grinding burn; magnification 100x.)

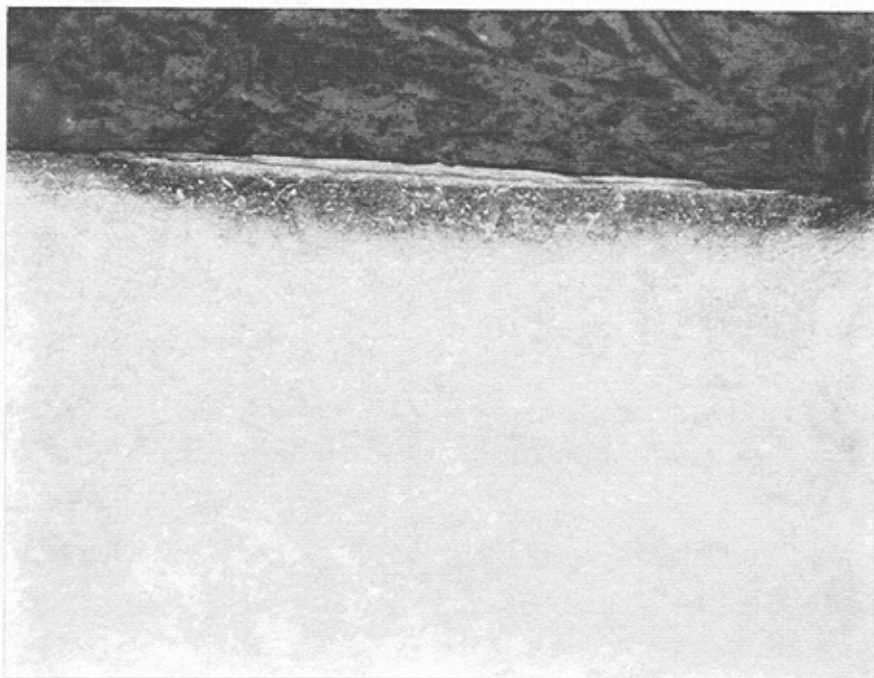
Figure 7. An Additional Grinding Burn Revealed Adjacent to the Fracture Origin, 0.43 Inch Away. (Note the white rehardened layer and the dark retempered layer; Vilella's reagent; magnification 150x.)

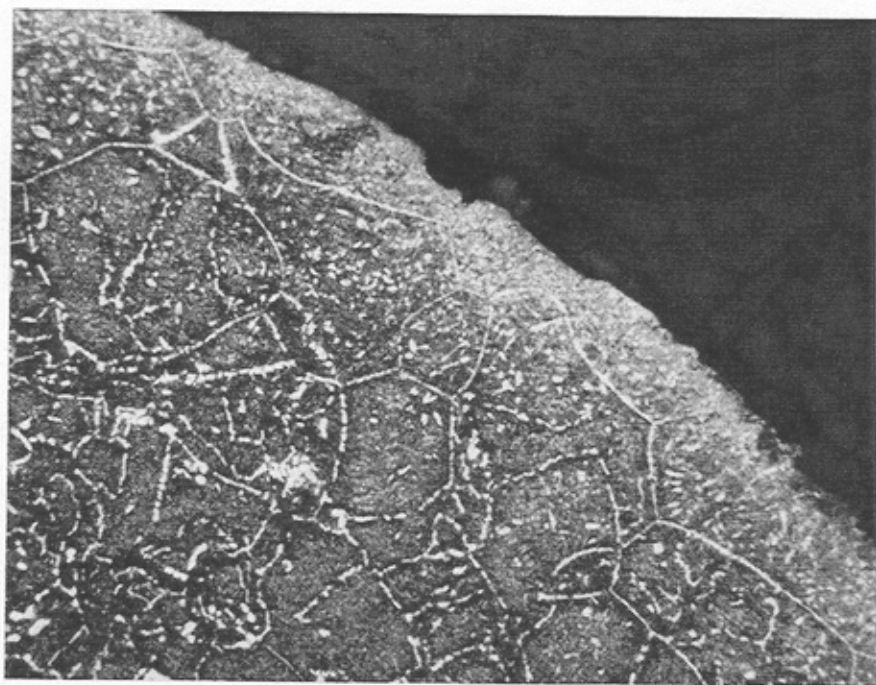
Figure 8. Metallographic Cross Section Through the Damping Ring Groove Region That was Double Carburized Inadvertently. (Note the carbide networks in the carburized case formed by this excess carbon; Vilella's reagent; magnification 400x.)

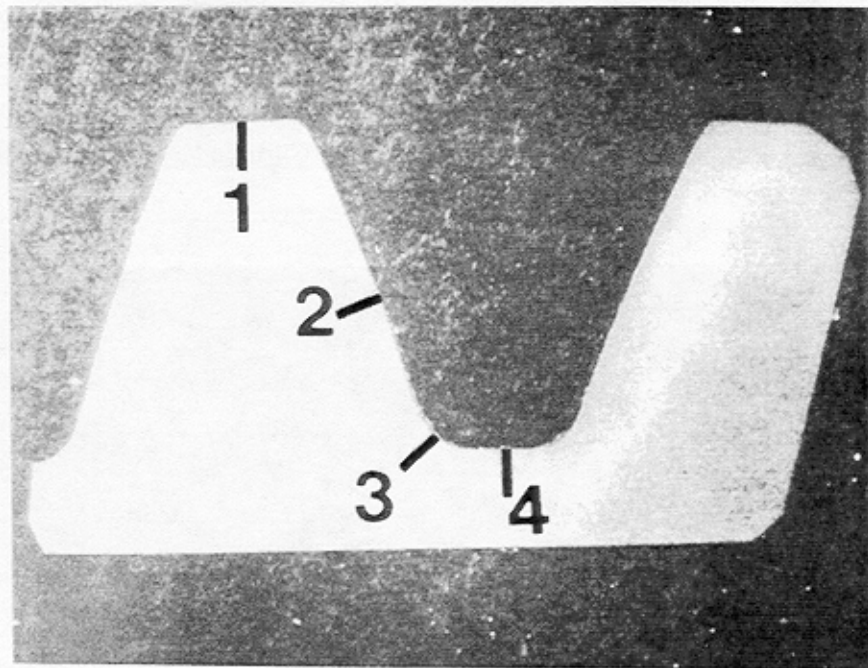
Representative damping ring and gear tooth metallographic samples were analyzed to determine the extent of carbide formation with respect to part geometry. Figures 9 and 10 highlight the areas examined for this investigation. Figures 11 through 14 show Areas 1 through 4, respectively, on the gear tooth sample. Note that carbide formation was heavier in Areas 1 and 2 (the locations with more surface area exposed to the carburization atmosphere). No carbide networks were noted in the areas of high stress (Areas 3 and 4). Figures 15 through 18 show Areas 1 through 4, respectively, of the damping ring groove sample. Note the heavy carbide formation in Area 4, with respect to Areas 1 through 3. The structure had the appearance of CCNs, which are unacceptable per Boeing Specification D210-10342-1 [3]. Also note that Area 4 is the point where the catastrophic failure originated.

Figure 9. Macrograph of a Gear Tooth Sample Showing the Areas in Which the Carburized Case was Examined for Evidence of Carbide Networks (Vilella's reagent; magnification 8x).

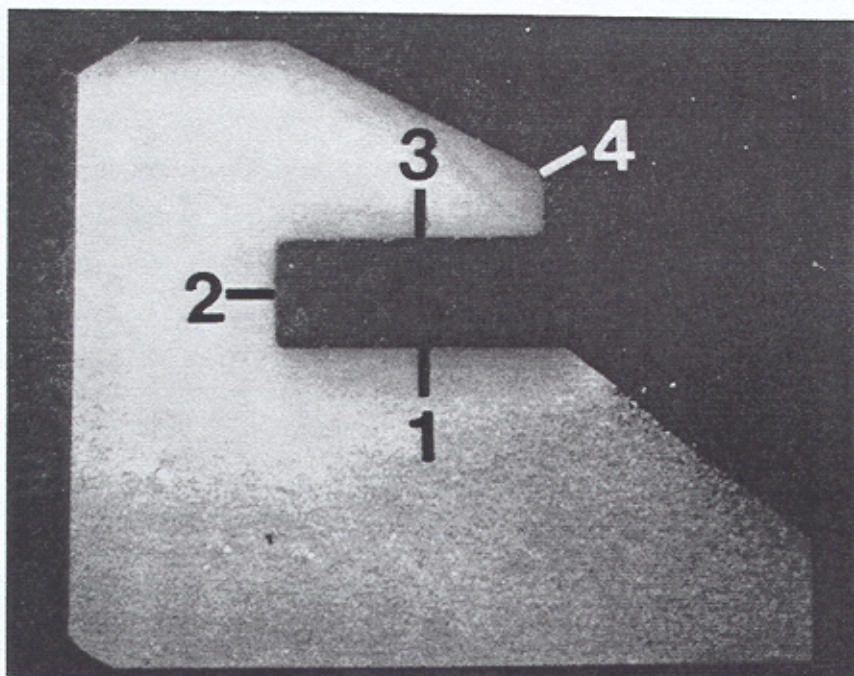
Figure 10. Macrograph of a Damping Ring Groove Sample Showing the Areas in Which the Carburized Case was Examined for Evidence of Carbide Networks (Vilella's reagent; magnification 8x).

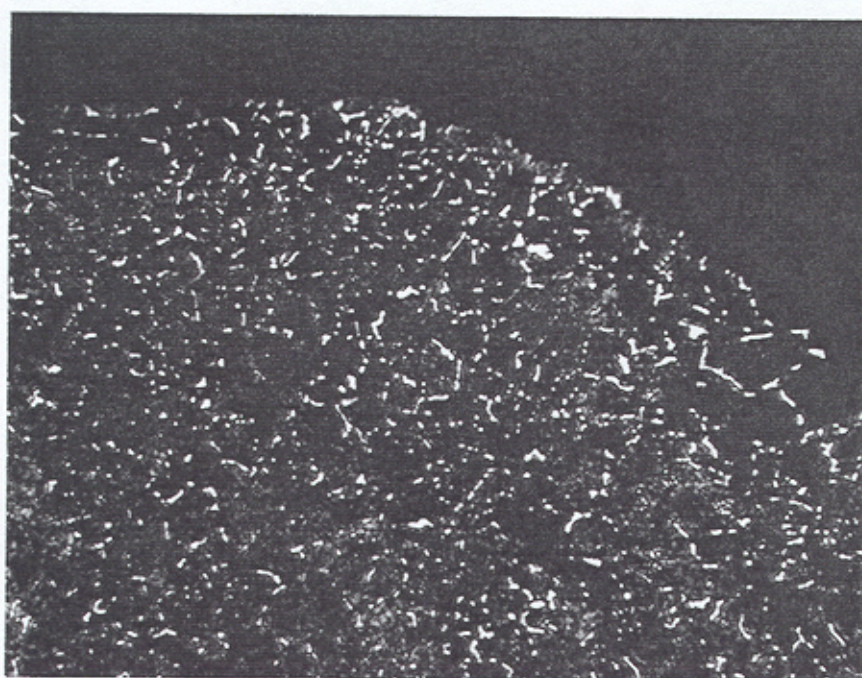
Figure 11. Micrograph of the Gear Tooth Metallographic Sample Showing the Case Microstructure Within Area 1 (Vilella's reagent; magnification 400x).

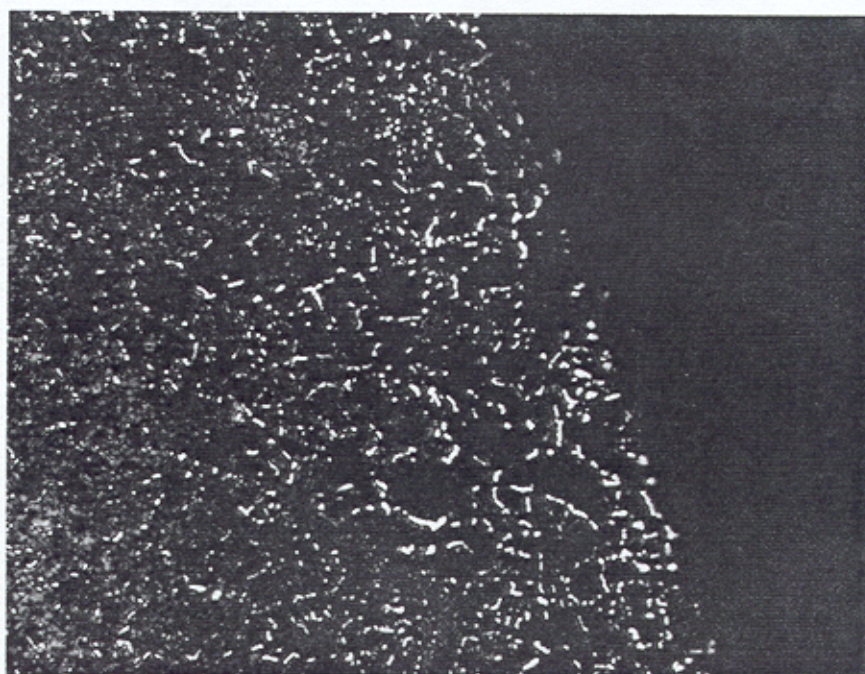
Figure 12. Micrograph of the Gear Tooth Metallographic Sample Showing the Case Microstructure Within Area 2 (Vilella's reagent; magnification 400x).

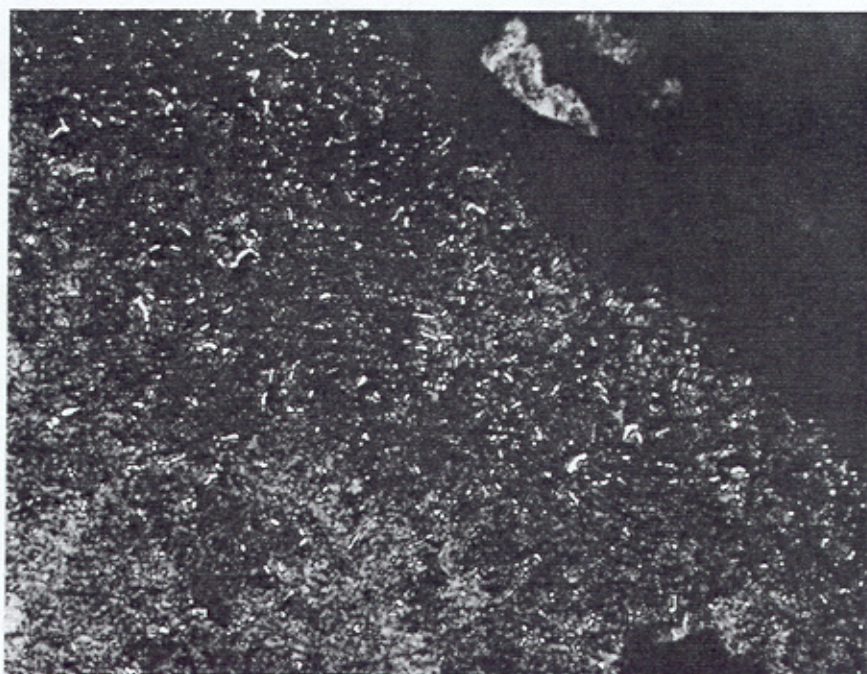
Figure 13. Micrograph of the Gear Tooth Metallographic Sample Showing the Case Microstructure Within Area 3 (Vilella's reagent; magnification 400x).

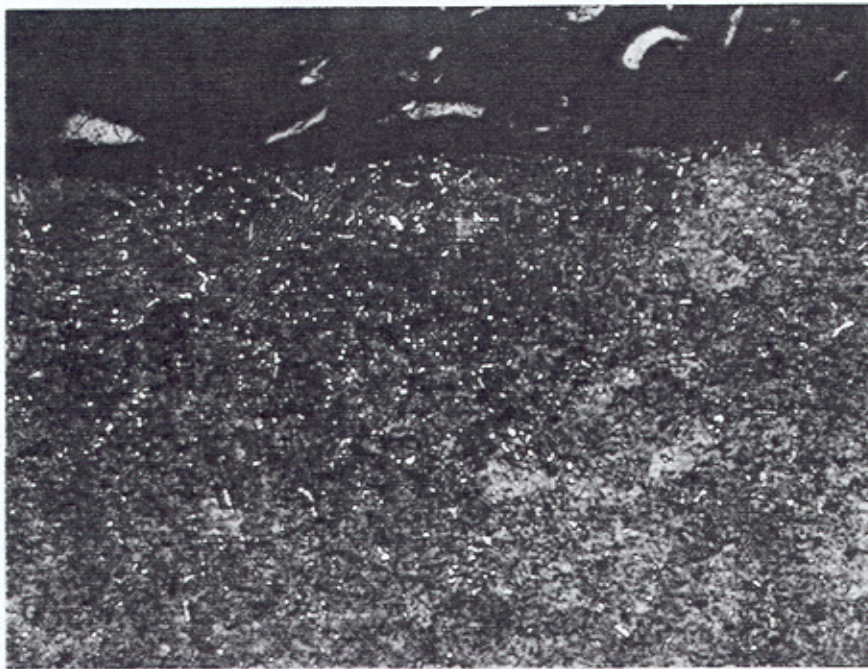
Figure 14. Micrograph of the Gear Tooth Metallographic Sample Showing the Case Microstructure Within Area 4 (Vilella's reagent; magnification 400x).

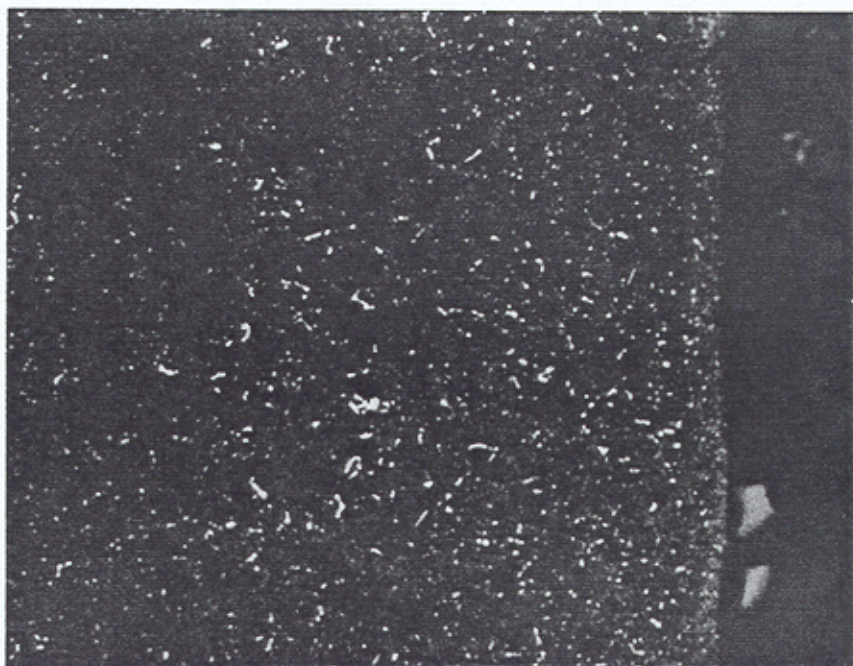
Figure 16. Micrograph of the Damping Ring Groove Metallographic Sample Showing the Case Microstructure Within Area 2 (Vilella's reagent; magnification 400x).

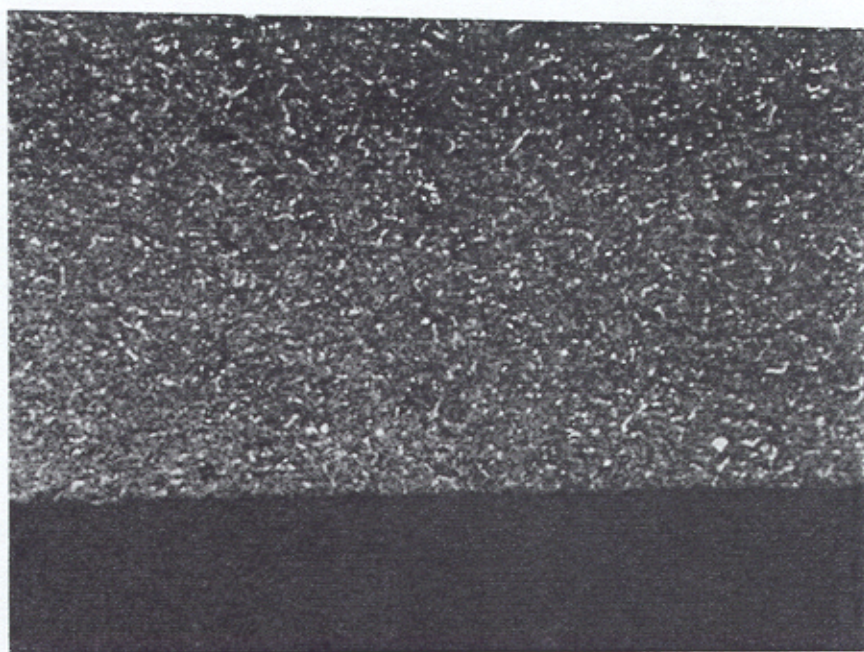
Figure 17. Micrograph of the Damping Ring Groove Metallographic Sample Showing the Case Microstructure Within Area 3 (Vilella's reagent; magnification 400x).

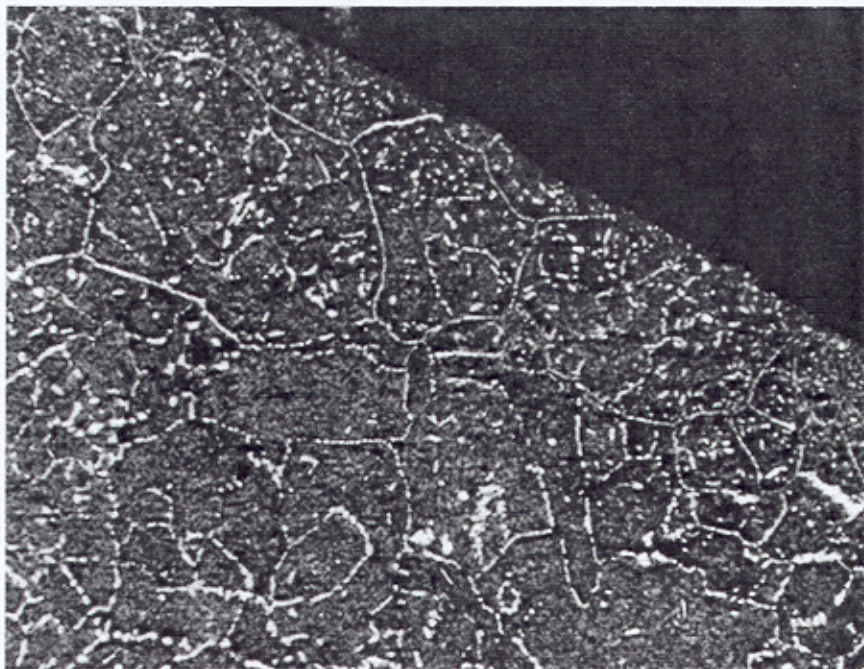
Figure 18. Micrograph of the Damping Ring Groove Metallographic Sample Showing the Case Microstructure Within Area 4 (Vilella's reagent; magnification 400x).

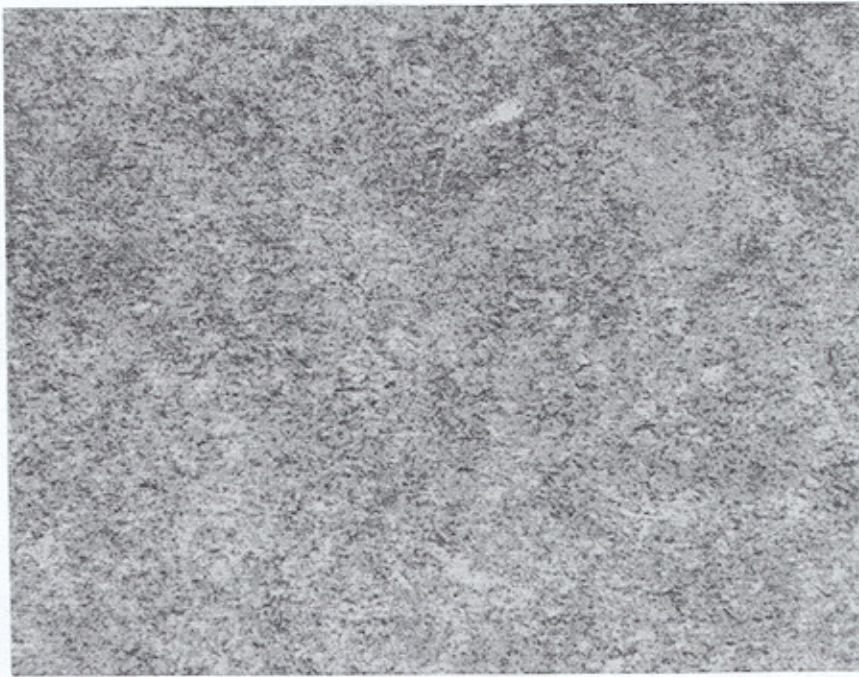
Figure 19. Micrograph of the Core Microstructure of the X-2M Steel Part. (The structure is consistent with the prior treatment; Vilella's reagent; magnification 200x.)

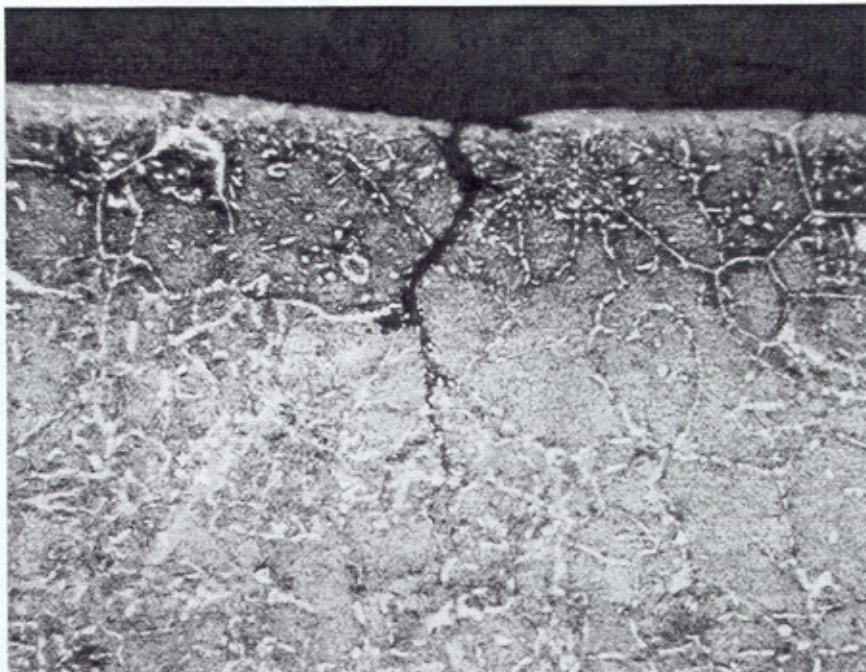
ARL examined a metallographic mount of spiral bevel gear P216, which Boeing had inadvertently included with the P196 gear parts when shipped to ARL. This sample was prepared and etched with Vilella's reagent by Boeing and exhibited the intergranular grinding crack shown in Figure 20. Although this part was not from the failed gear being investigated, and grinding cracks in this material have been known to travel in either an intergranular or transgranular direction, it served as an example of a grinding crack in X-2M steel following the path of a carbide network.

Figure 20. Micrograph of an Intergranular Crack Propagating Along a Carbide Network Noted in Gear P216. (This was not the failed gear being investigated, but this sample provided an example of a grinding crack following the path of a carbide network in X-2M steel; Vilella's reagent; magnification 400x.)

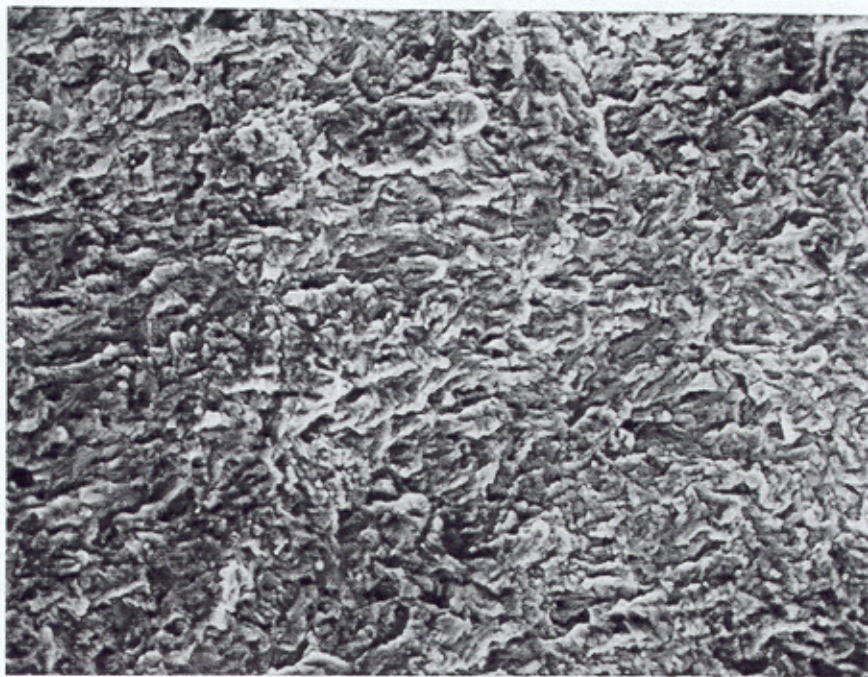
Figure 22. Scanning Electron Micrograph of the Fatigue Morphology, Predominant on the Primary Fracture Surface (magnification 1000x).

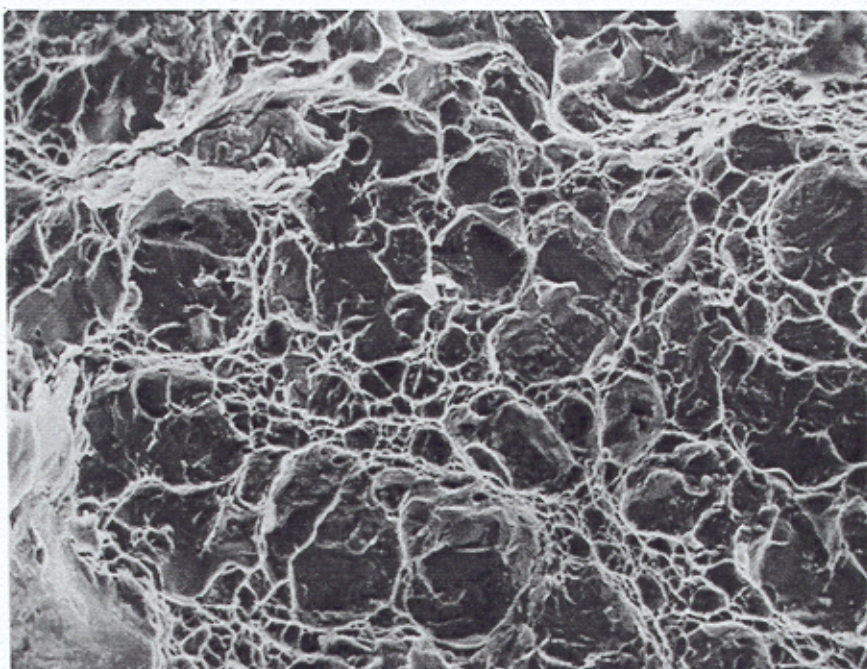
Figure 23. Scanning Electron Micrograph of the Overload Morphology. Noted on the Remaining Primary Fracture Surface (magnification 500x).

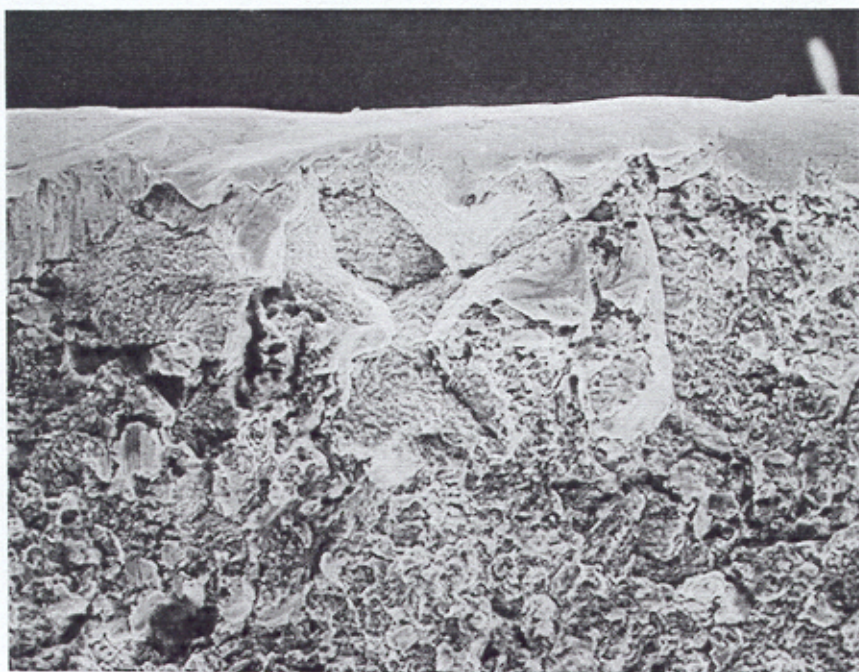
0.08 inch away from the origin along the 30° tapered surface, an intergranular morphology was noted, as shown in Figure 24. This was the region that displayed CCNs during metallographic examination, and it is believed the grinding crack responsible for this failure propagated along these networks.

Figure 24. Scanning Electron Micrograph of the Intergranular Morphology Noted Within the Carburized Case, Noted 0.08 Inch Away From the Primary Fracture Origin (magnification 400x).

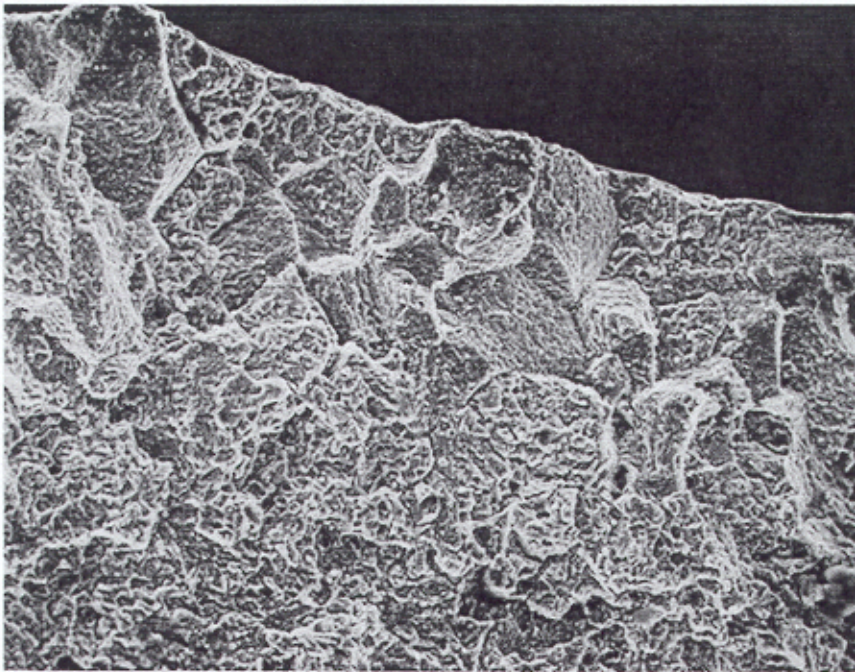
Figure 27. Scanning Electron Micrograph Showing the Intergranular Morphology of Figure 26 at Higher Magnification (magnification 400x).

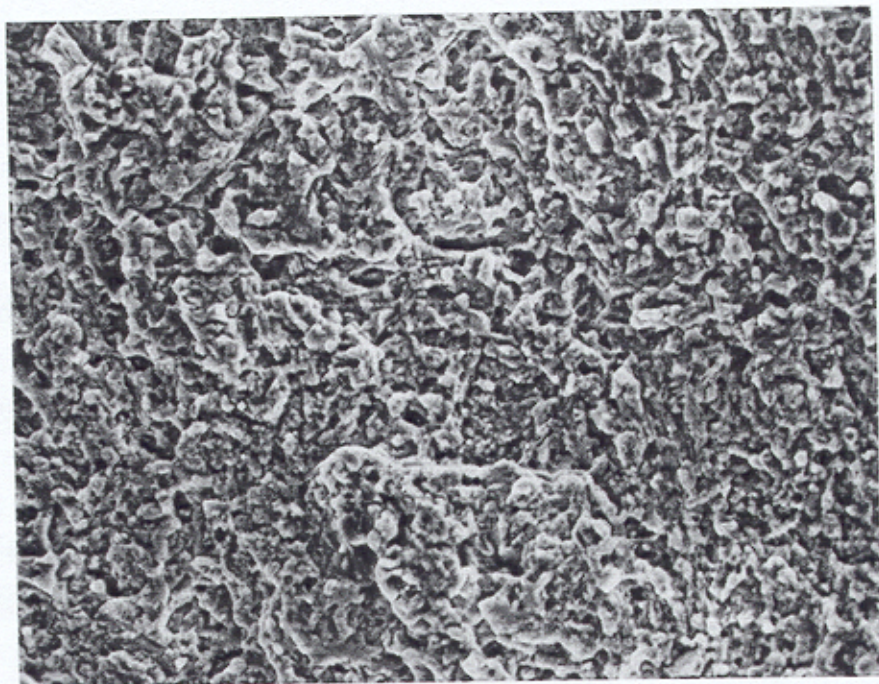
Figure 28. Scanning Electron Micrograph Showing a Morphology Consistent With the Fatigue Region Noted Within the Primary Fracture (see Figure 22). (This region was located between the intergranular and overload zones; magnification 1000x.)

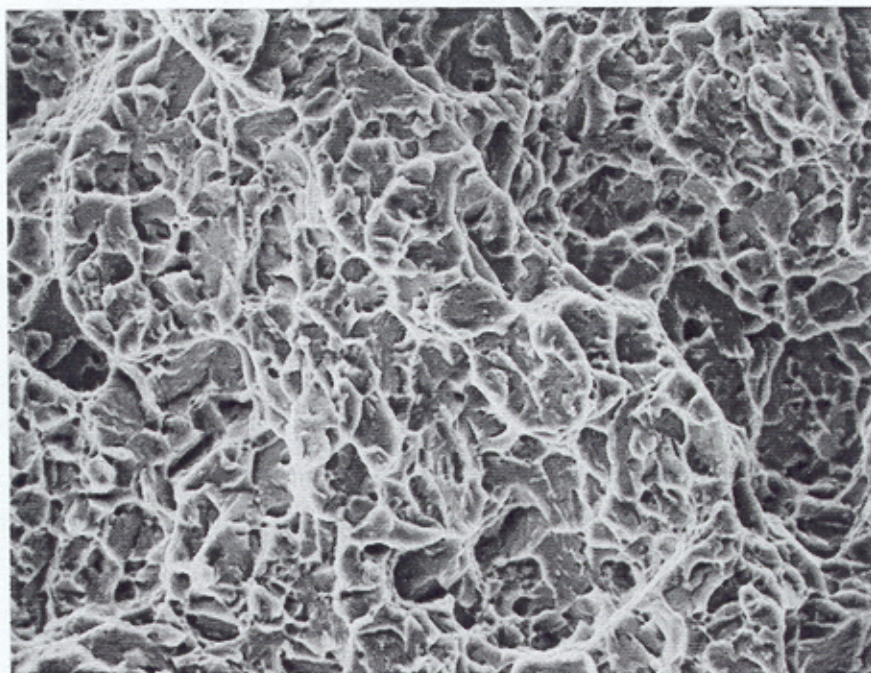
Figure 29. Scanning Electron Micrograph Showing the Overload Morphology Noted at the Center of the Failed Piece (magnification 1000x).

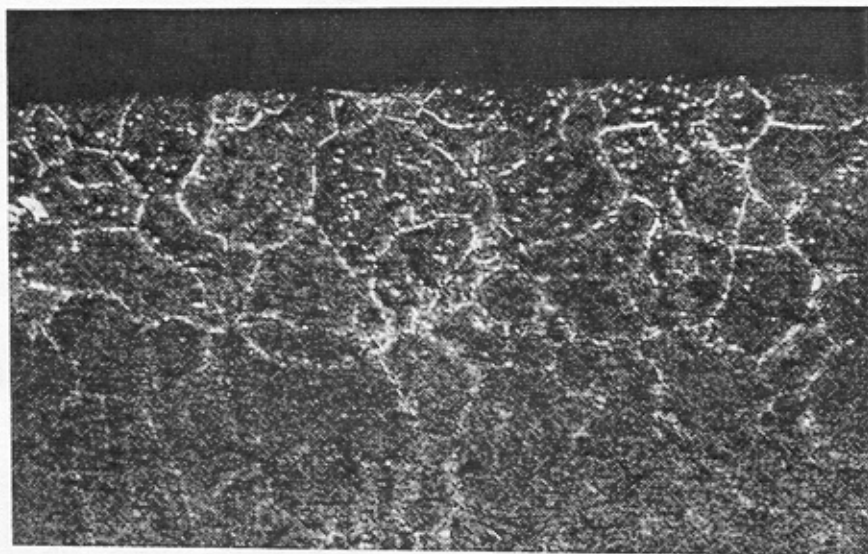
A joint effort was undertaken by the Army and Boeing from 1982 to 1990 to optimize a high temperature vacuum carburizing procedure for AISI 9310 gear steel and X-2M steel (Contract No. DAAG46-82-C-0034). This process would significantly reduce the processing time for gears, and ultimately lower the cost. The program was successful for AISI 9310, but not for X-2M. The process was not optimized for the X-2M steel primarily because of the presence of CCNs upon carburizing. As a result of this program, a contractor technical report (Materials Technology Lab [MTL] TR 90-42) was written entitled, "Aircraft Quality High Temperature Vacuum Carburizing" [10]. This report states that "CCNs are an undesirable condition for good bending fatigue resistance" and "refinements to the vacuum carburizing technique for X-2M were undertaken to eliminate this type of unwanted structure." This report contains a micrograph of an unacceptable X-2M case microstructure (shown in Figure 30). This structure is quite similar to that of the double carburized 30 degree taper sample from the damping ring groove region (compare to Figure 8).

Figure 30. A Micrograph Taken From Boeing's Technical Report, "Aircraft Quality High Temperature Vacuum Carburizing." (This structure was deemed unacceptable because of CCNs. Compare this structure to that of the failed component [see Figure 8], taken within the double carburized 30° taper region; magnification 400x.)
